**Lakeside Union School District
Long Range Facilities Master
Plan**

**FINAL
Board Approved
September 10, 2018**

LONG RANGE MAINTENANCE MASTER PLAN 2016 – 2021

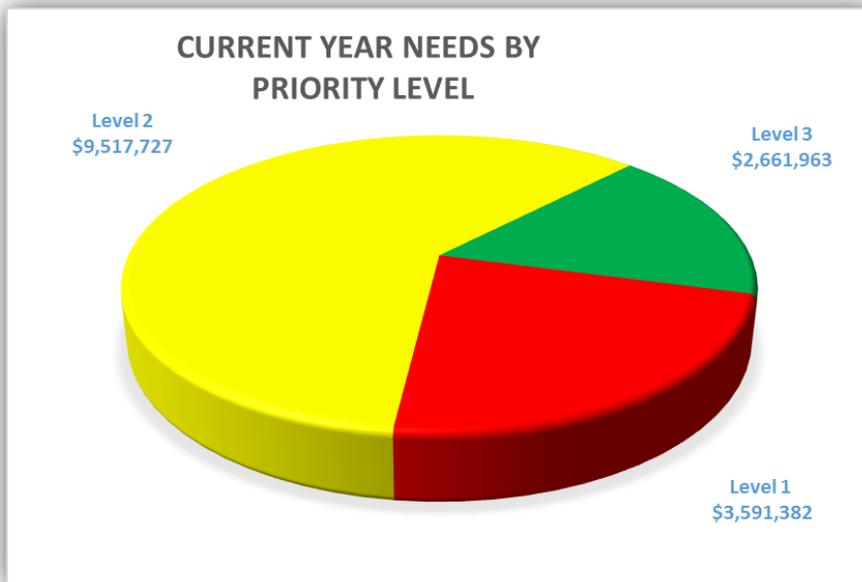
The following chart summarizes the comparative costs associated with the current backlog of maintenance deficiencies by priority level. This chart gives some reference to the scale of the cumulative deficiencies, and provides the district insight into how best to use its available funding for maintenance projects.

The current backlog of maintenance deficiencies is approximately \$15.8 million (above) **not including project-related soft costs**. This backlog includes systems that have surpassed their expected useful life, or are in a state of failure and need to be replaced. This amount far exceeds the district’s ability to fund all of these projects, therefore, projects must be prioritized until additional funding can be secured. Projects have been prioritized into three categories based on information received from staff, and visual observations.

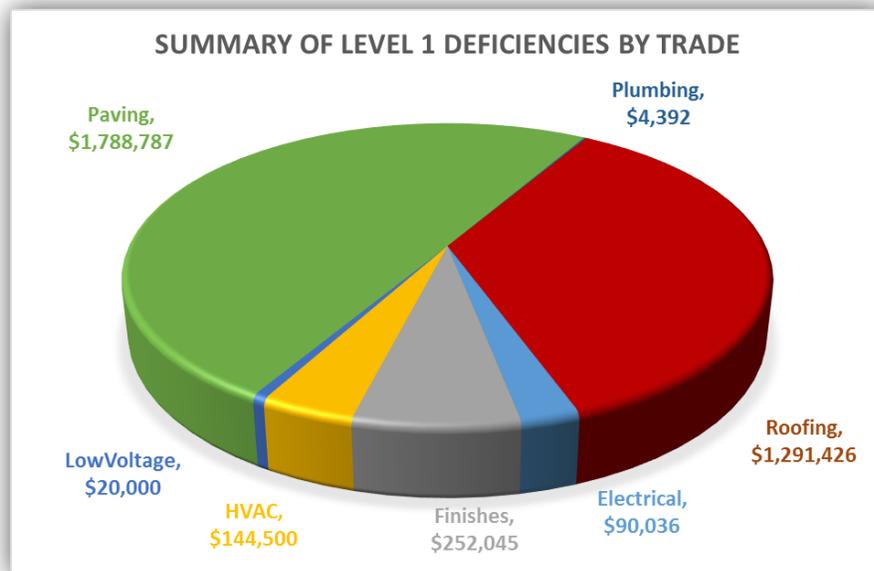
Level I priority projects predominately consist of roofing and paving as shown in the chart below. Other systems comprise a relatively small portion of Level I deficiencies and this is intended to aid the district in prioritizing project funding. Expired facility assets are not represented in the chart below. This includes equipment that has exceeded its life expectancy and should be replaced due to its age, but it is still operational. Since these other assets are not in a critical state of disrepair, they are not included in this summary of Level I needs. Such equipment is included in the site-by-site summary in Appendix A.

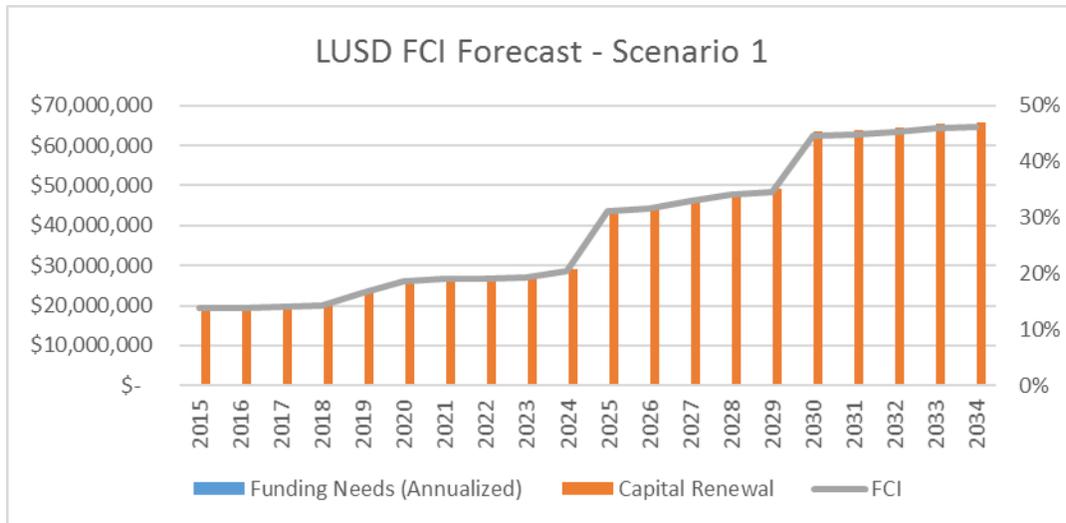
This “Do Nothing” scenario highlights the overall effect of neglecting facility funding to address current and on-going facility needs district wide over the forecast period. The grey line represents the annual FCI over the funding cycle based on year to year funding and cumulative facility needs. The orange bar represents the cumulative capital renewal cost associated with facility needs.

The district is currently in fair condition, but neglecting facility funding will have a detrimental effect on the overall quality and condition of the district’s buildings. Under this scenario, the district wide condition index will fall from “fair” to “poor” by 2025, and will exceed 50% some time after 2035.

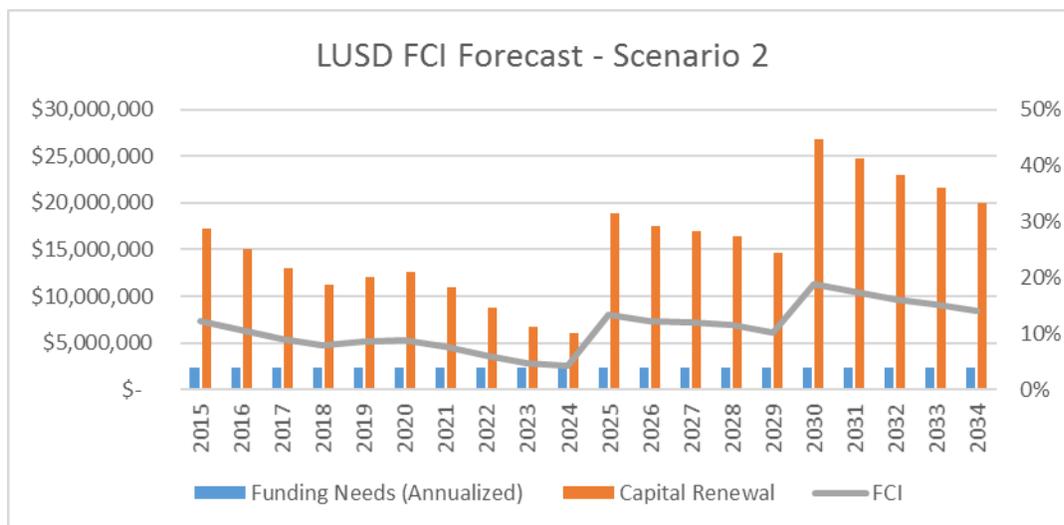
The current backlog of deficiencies constitutes a substantial portion of the ongoing needs of the district. A commitment of funds towards capital maintenance projects in the first year would alter the outcome of this report, thereby reducing the district’s overall FCI.

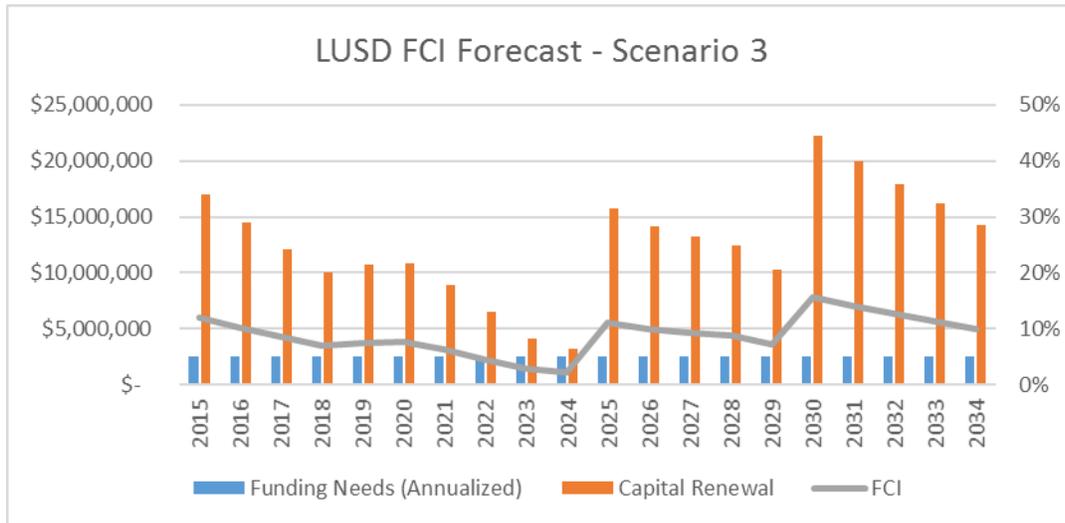
This scenario examines the funding needed to address the facility condition deficiencies and renewals over the forecast period at an FCI of 10%, considered “Good Repair.” The grey line represents the annual FCI over the funding cycle based on year to year funding and cumulative facility needs. The orange bar represents the cumulative capital renewal cost associated with facility needs. The blue bar shows the capital investment needed in order to maintain the facilities at 10%. The total amount of funds needed over this forecast period is \$51,647,866 or an average of \$2,582,393 per year as shown.
